Manhole Inspection Summary

Manhole # S23UU1009MH

Location Address: **104 HARVEST RD**

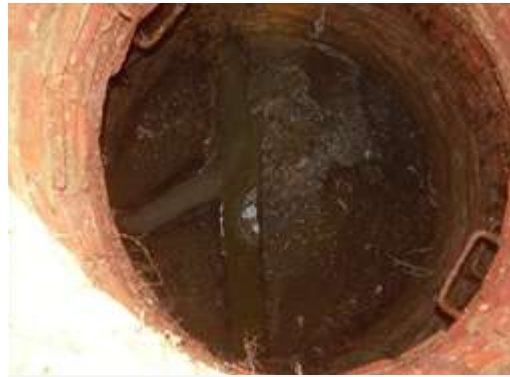
Top View

Corroded steps. Evidence of surcharge - Bench debris. Channel debris.

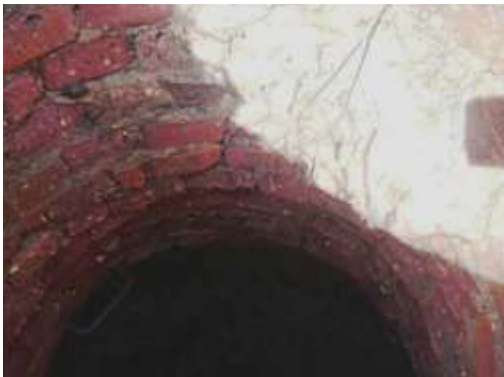
Defect

Condition: ☐ Sound ☐ Cracked ☒ **Root Intrusion** ☐ Loose Brick ☒ **Deteriorated**

Infiltration: ☐ None ☒ **Joint** ☐ Cracks ☒ **Mortar** ☒ **Roots** ☐ Wall

Infiltration: ☐ None ☐ Joint ☐ Cracks ☒ **Mortar** ☒ **Roots** ☐ Wall

Corbel and Barrel deterioration, root intrusion and infiltration.

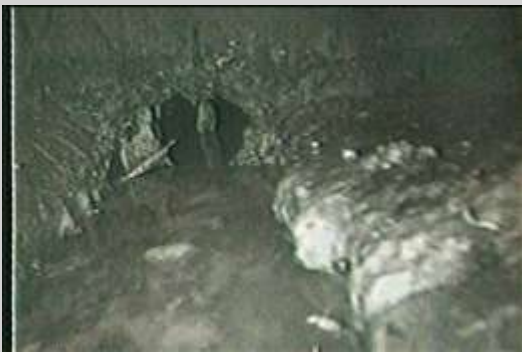
6 in. Circular Gravity Sewer Pipe Out @ 12 O'Clock

Deposits: ☐ None ☐ Mud ☐ Sludge ☒ **Debris** ☐ Grease

Infiltration: **None** Pipe Seal Cond: **Roots**

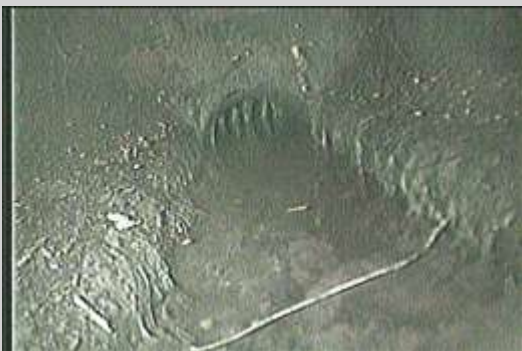
6 in. Circular Gravity Sewer Pipe In @ 6 O'Clock

Barrel deterioration, root intrusion and infiltration.

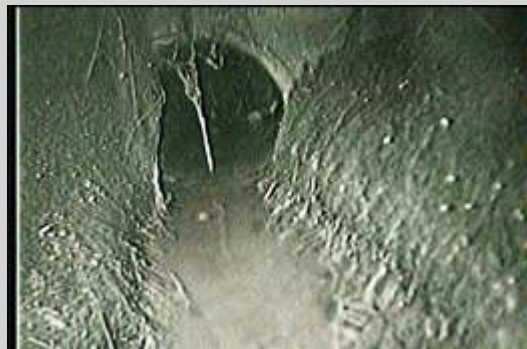
6 in. Circular Gravity Sewer

Barrel and Channel root intrusion.

Pipe Seal Cond: **Roots**
